First-in-Human Experience With Integration of a Hydrocephalus Shunt Device Within a Customized Cranial Implant

Operative Neurosurgery 0:1–8, 2019

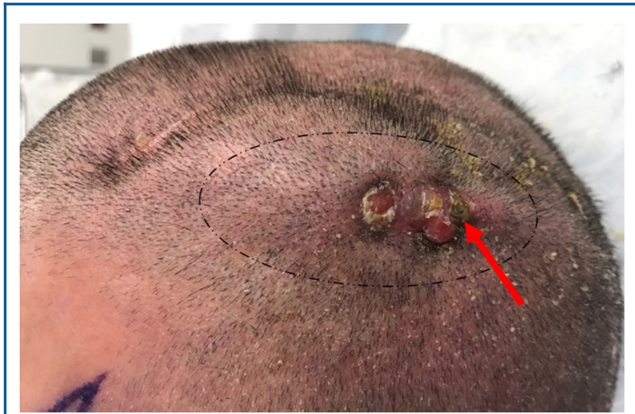
FIGURE 1. Preoperative photograph of inaugural patient presenting to neuroplastic surgery clinic with, left-sided scalp wound and extruding shunt valve. One can appreciate the high-profile shunt's visible deformity (represented by dotted black line), as well as the exposed valve (red arrow).

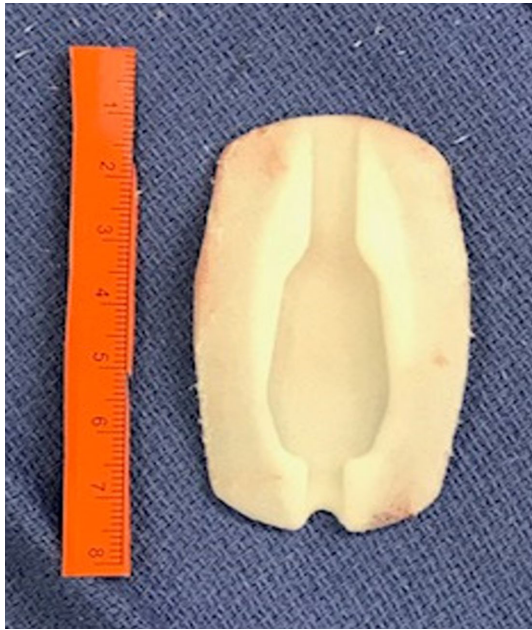
FIGURE 2. Intraoperative photograph of customized cranial implant made of high-density polyethylene. In particular, there is an exact fit design incorporated within the customized implant to accommodate the specific shunt valve system being selected by the neurosurgeon.

During this time, a customized cranial implant (InvisiShunt, Longevity Neuro Solutions, Hunt Valley, Maryland) was designed specifically to house the exact shunt valve type planned for future implantation by neurosurgery (M.L.). Computer-assisted design/manufacturing (CAD/CAM) was performed in virtual fashion to allow the multidisciplinary team to coordinate exact locations with respect to contralateral shunt placement, planned craniectomy boundaries, and incisional/scalp flap exposure. Of note, the cranial implant was requested to be made out of high-density polyethylene, so that its mechanical properties would allow for intraoperative modification and flexibility as needed to better accommodate the convex curvature of the cranium—as opposed to a more rigid alloplastic material like poly-ether-ether-ketone or polymethyl-methacrylate. Of note, the upfront cost for this specific implant was institutional-dependent based on prenegotiated terms with the manufacturer. Furthermore, the cost of the implant is a fraction of the cost of a redo shunt and hospitalization.

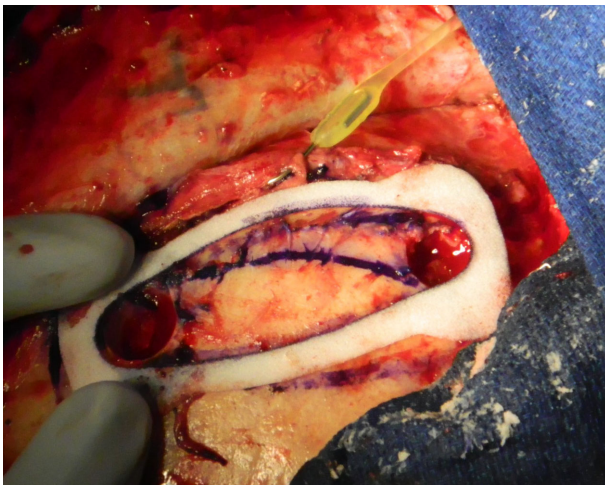
FIGURE 3. Intraoperative photograph of marking template being used to identify exact burr hole locations on either end. Next, a craniotome is used to complete the limited craniectomy.

At 2 wk, the second-stage surgery was performed on the contralateral side since the patient had communicating hydrocephalus, and in an effort to avoid the previously contaminated field/scarred scalp (**Video, Supplemental Digital Content**). The borders of the limited craniectomy were hand-drawn using a marking pen and template, as shown in Figure 2. Of note, the size of the limited craniectomy was oval-shaped and measured approximately 3.5 × 6.5 cm (Figure 3). The size limits of the craniectomy

In this particular instance, the main precipitating factor was the high-profile, rigid shunt device and its pressure on the overlying scalp. Therefore, to address this, we performed a small-sized craniectomy using a burr and craniotome (by way of a predesigned marking template supplied by the manufacturer). Attempting to drill a partial-thickness cranial defect to mirror the necessary shunt device would have been quite challenging given

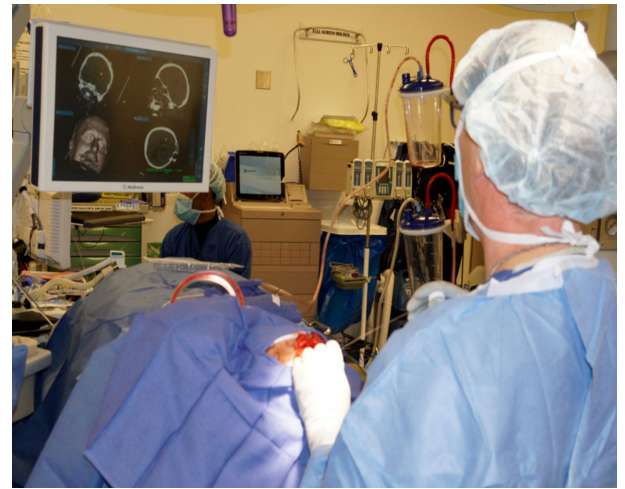
FIGURE 4. Intraoperative photograph of proximal catheter being placed via navigational guidance.

were determined based on length and width of the device. The proximal catheter was placed uneventfully in the lateral ventricle using intraoperative guidance (Figure 4). The distal catheter was placed in the peritoneal cavity using standard technique. Once both catheters were in proper position, the customized cranial implant was inset within the limited craniectomy defect and fixated with titanium screws along the periphery (Figure 5). The high-profile shunt device was then integrated within the implant, and the proximal catheter was passed through and connected. The distal catheter was connected and positioned within a customized groove at an angle less than 90 degrees. Following integration, the shunt valve was measured before inset to be 8 mm tall. Following implantation within the customized cranial implant, its relative height was reduced to just 1 mm, which left its edges just high enough to palpate

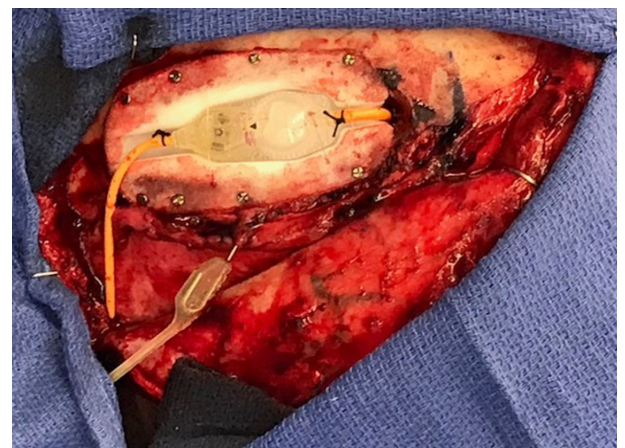
FIGURE 5. Intraoperative photograph of high-profile shunt valve implanted within customized cranial implant along right-sided temporoparietal location. Titanium screws fixate the cranial implant along the periphery.

its 3-dimensional shape. Furthermore, a partial-thickness defect may have only reduced the overall thickness by 1 to 2 mm.¹² As such, following a prolonged discussion with the patient in regard to the novelty of this approach, we decided to use a low-profile customized implant to reduce the valve's height by 87%, and at the same time, eliminate all concern for shunt migration by providing a "key-and-lock" type fit (Figure 5).

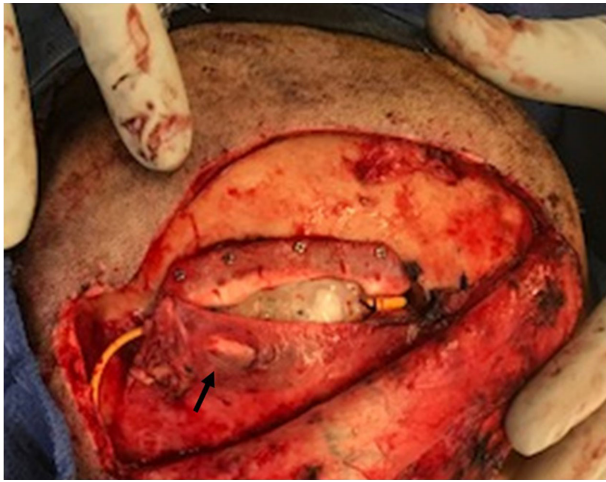
FIGURE 6. Intraoperative photograph showing the re-draping and inset of a pericranial-temporalis muscle flap over the inferior shunt valve/cranial implant in preparation for final scalp closure.

subcutaneously with one's fingers. Proper function and shunt flow were confirmed prior to flap inset, multilayered scalp closure, and closed suction drain insertion (Figures 6 and 7).

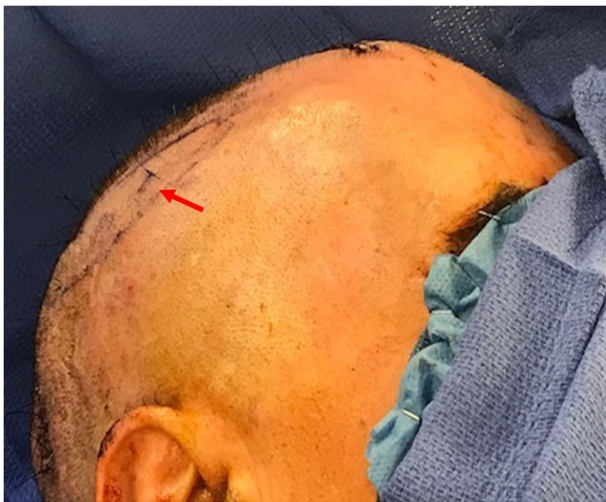
FIGURE 7. Right-sided intraoperative photograph of the final cranial contour following multilayered scalp closure. Of note, a single suture (red arrow) was placed above the low-profile shunt valve for this inaugural case to assist with postoperative device identification.

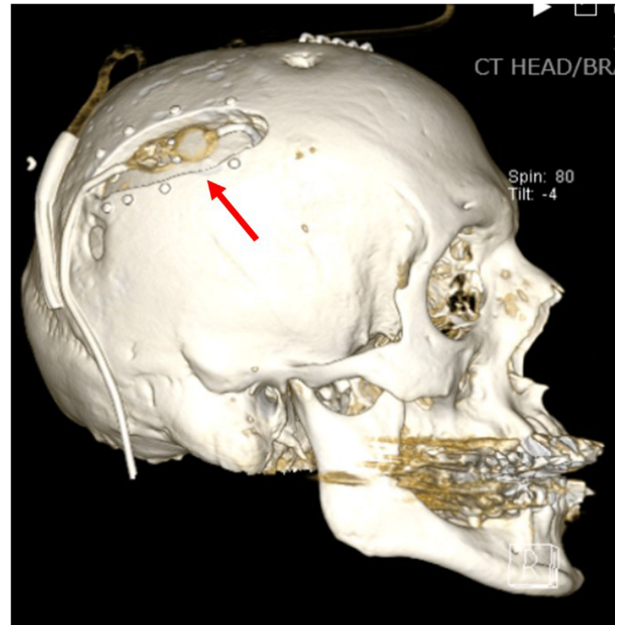
FIGURE 8. Postoperative CT scan with 3-dimensional reconstruction showing right-sided hydrocephalus shunt valve implantation within a customized cranial implant. In particular, the high-density polyethylene cranial implant is radiolucent and cannot be seen within the craniectomy site.

cranial implant has not interfered with any shunt programming or valve localization. To date, his hydrocephalus has remained well controlled. In particular, the overall height of his shunt valve device was decreased by 87%, as compared to its previous placement height which led to eventual extrusion (Figure 8). Overall, there is a significant difference in shunt valve prominence as compared to its previous placement, as shown in Figure 9.

Unquestionably, shunt-related complications are devastating to all patients regardless of age, ranging from simple adjustment to definitive removal. Although these complications are complex and multifactorial, the scalp-related variables play a major factor in cases of extrusion/failure and therefore, with this advance, could be prevented by way of a low-profile inset. As such, the ability to securely house shunt valves within the confines of a craniectomy defect (ie, intercranial space) by taking advantage of underutilized space within a cranial implant provides many newfound advantages (Figure 11).¹⁴⁻¹⁶ This includes offering our patients an option for an improved appearance with enhanced contour, while concurrently decreasing detrimental pressure and relative ischemia onto their overlying scalp (Figures 8 and 9).

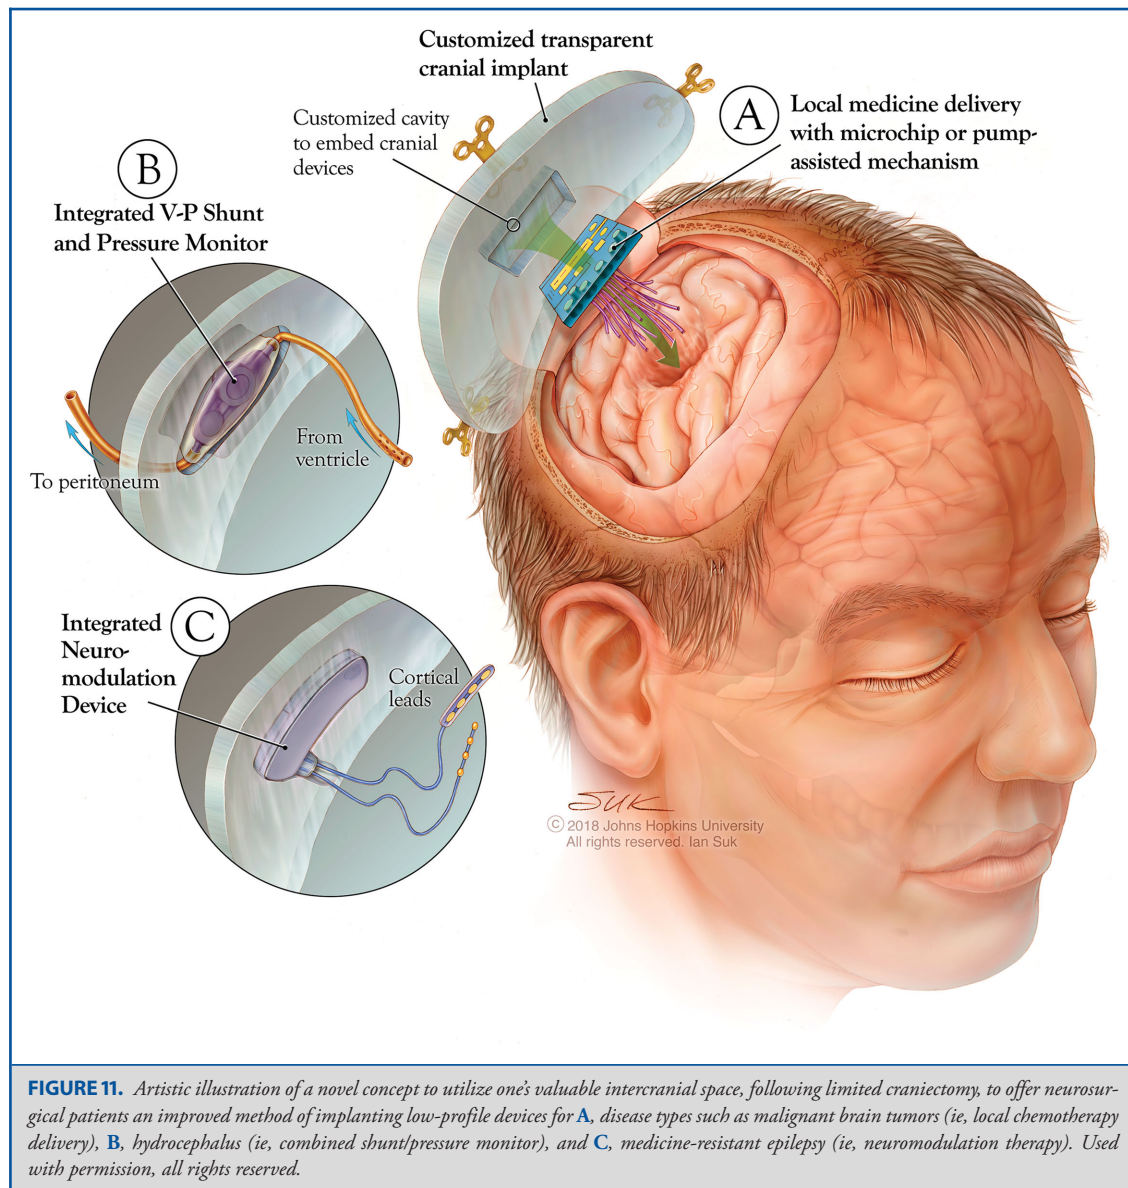
FIGURE 11. Artistic illustration of a novel concept to utilize one's valuable intercranial space, following limited craniectomy, to offer neurosurgical patients an improved method of implanting low-profile devices for **A**, disease types such as malignant brain tumors (ie, local chemotherapy delivery), **B**, hydrocephalus (ie, combined shunt/pressure monitor), and **C**, medicine-resistant epilepsy (ie, neuromodulation therapy). Used with permission, all rights reserved.
